**REMOVAL PROGRAM
AFTER ACTION REPORT
FOR THE
PARK STREET SITE
(b) (6)
BENNINGTON, BENNINGTON COUNTY, VERMONT
17 SEPTEMBER THROUGH 12 JULY 2013**

U.S. Environmental Protection Agency
Region I
Emergency Planning and Response Branch
5 Post Office Square, Suite 100
Boston, Massachusetts 02109-3912

Weston Solutions, Inc.
Superfund Technical Assessment and Response Team III (START)
3 Riverside Drive
Andover, Massachusetts 01810

September 2013

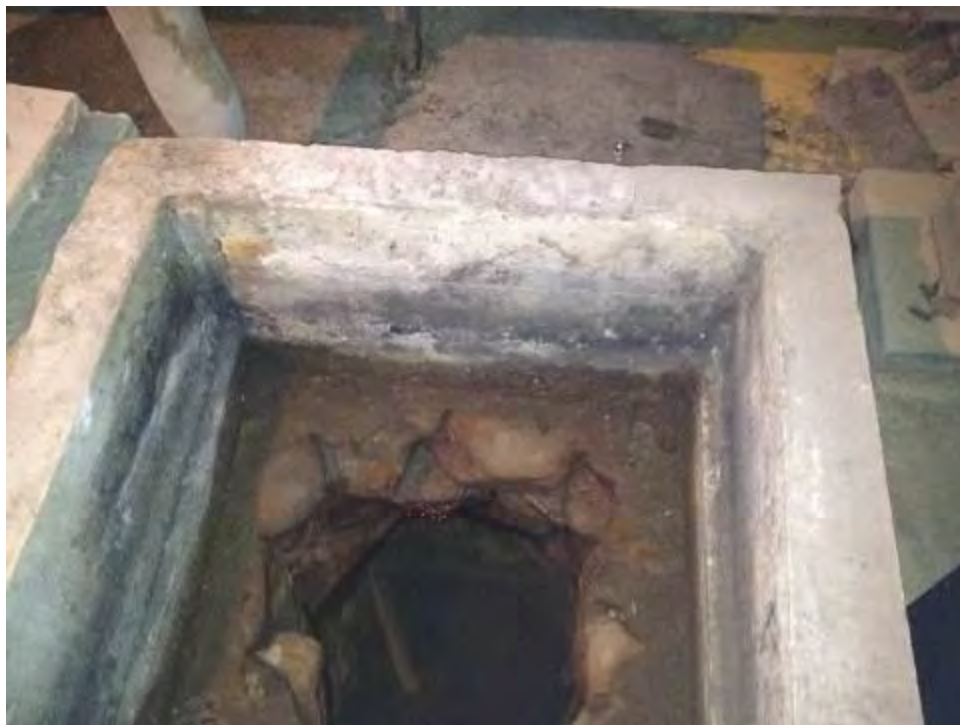
SCENE: View of a well located in the basement of (b) (6) prior to decontamination.

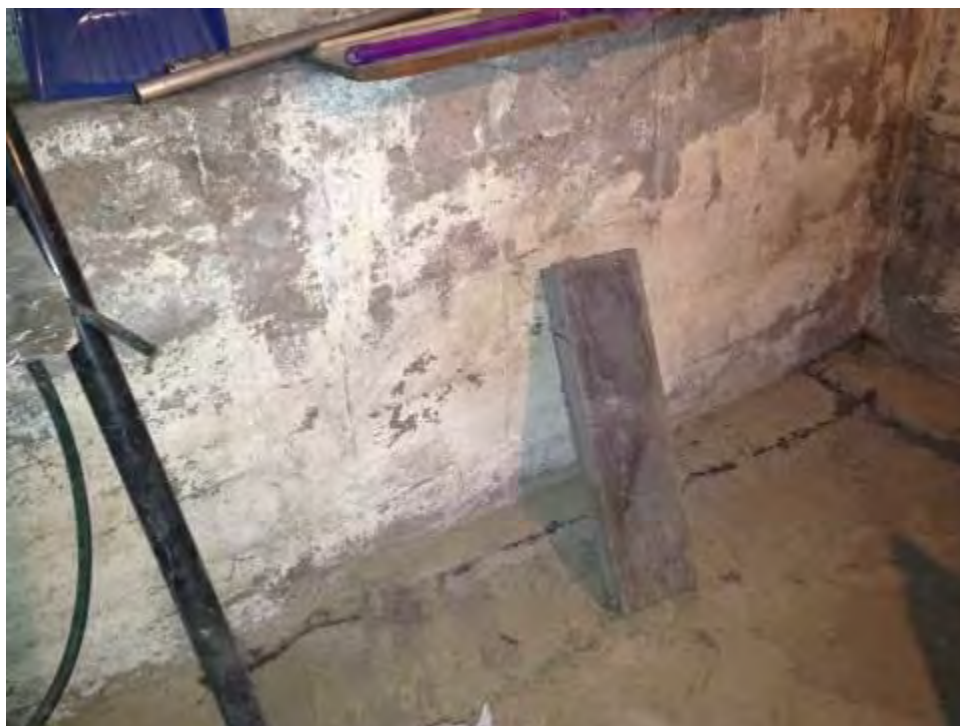
SCENE: View of the northern basement wall at (b) (6) prior to decontamination.

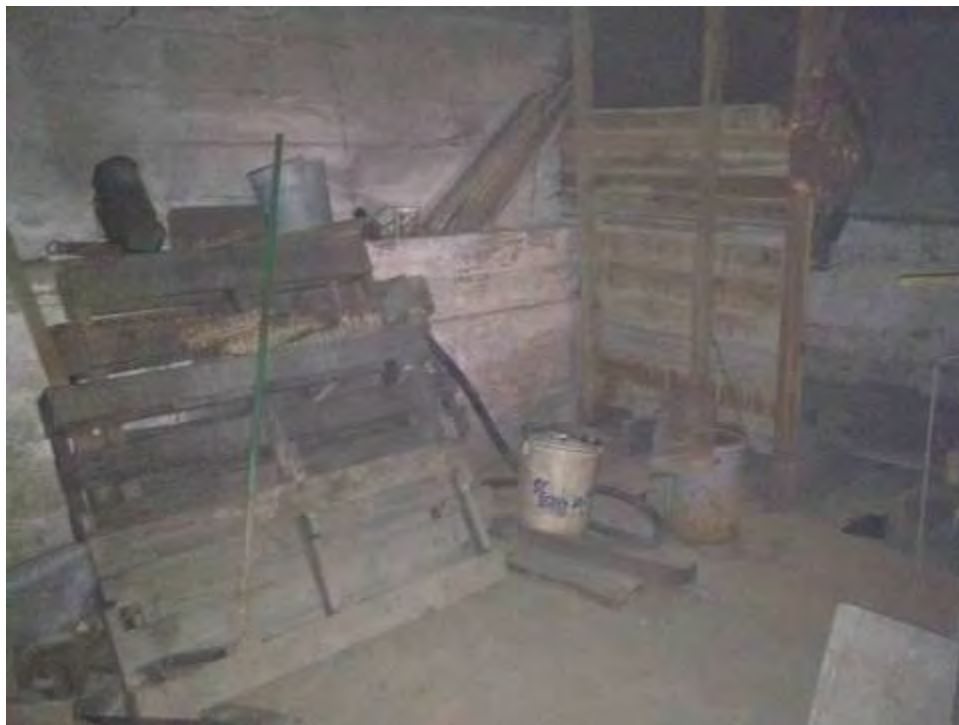
SCENE: View of the northwestern basement wall at (b) (6) prior to decontamination.

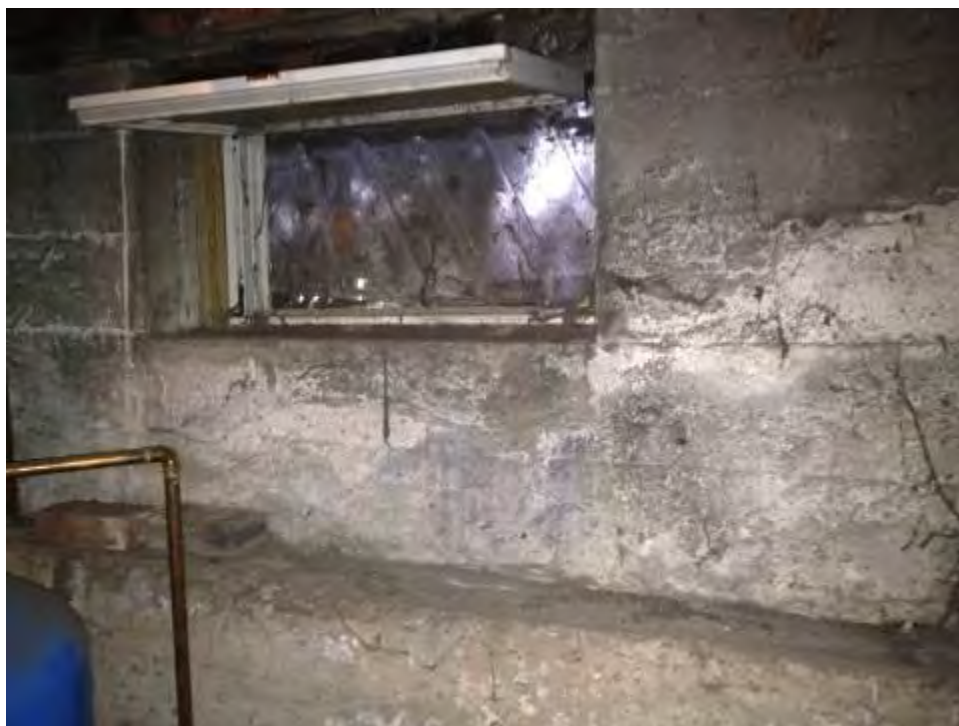
SCENE: View of a window located along the southern basement wall at (b) (6) prior to decontamination.

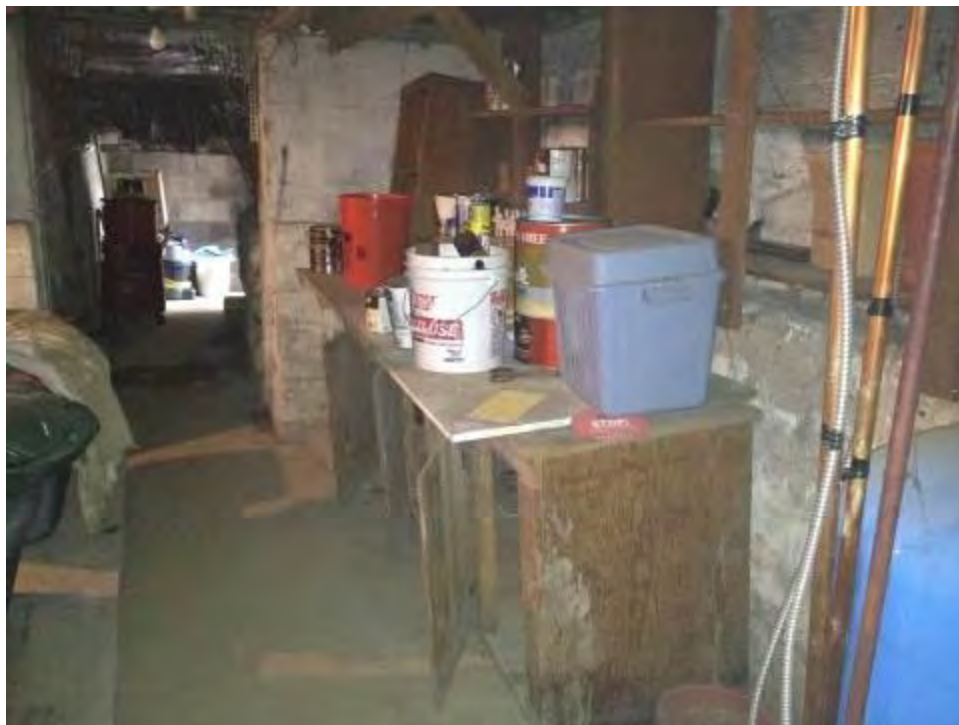
SCENE: View of the southern basement wall (to the right) at (b) (6) prior to decontamination.

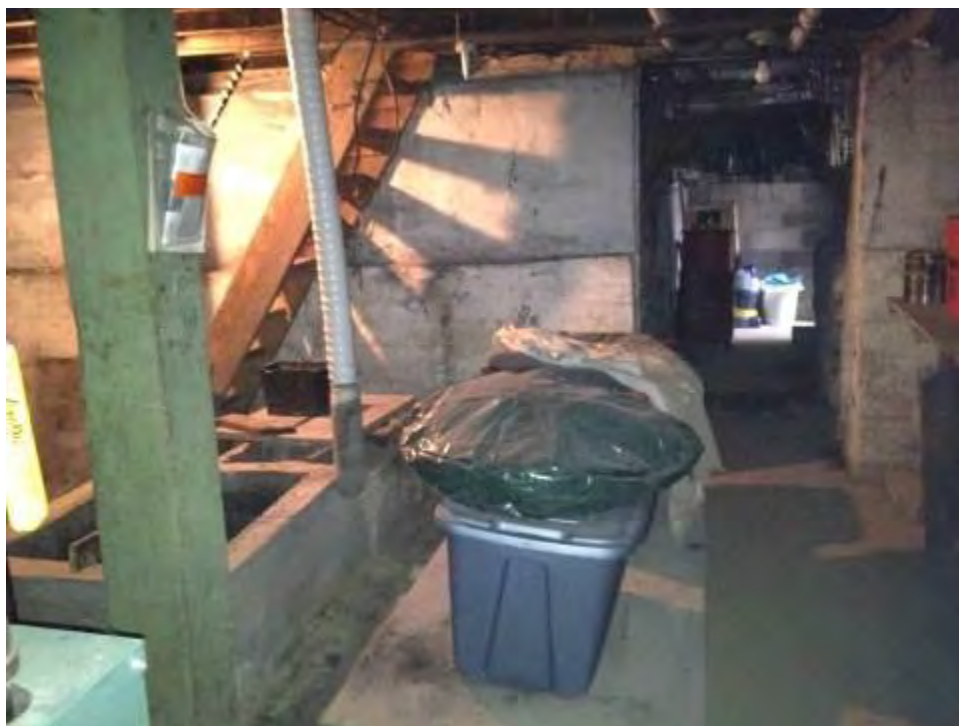
SCENE: View of the central and eastern area in the basement at (b) (6) prior to decontamination.

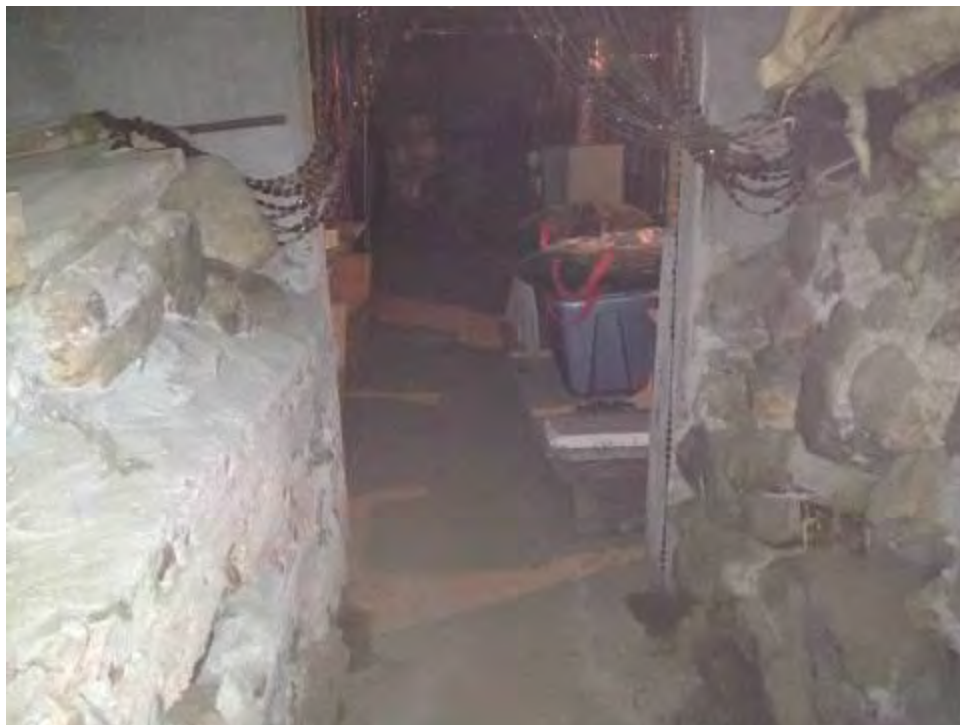
SCENE: View of a hall leading from the bulkhead door to the basement at (b) (6). Wet areas are visible at the base of the stone foundation wall.

- Mobilizing the crew and equipment.
- Reviewing and signing the site HASP.
- Installing a poly liner in a hallway leading from the bulkhead at (b) (6).
- Returning all basement items back to their original locations after the basement waterproofing activities were completed.

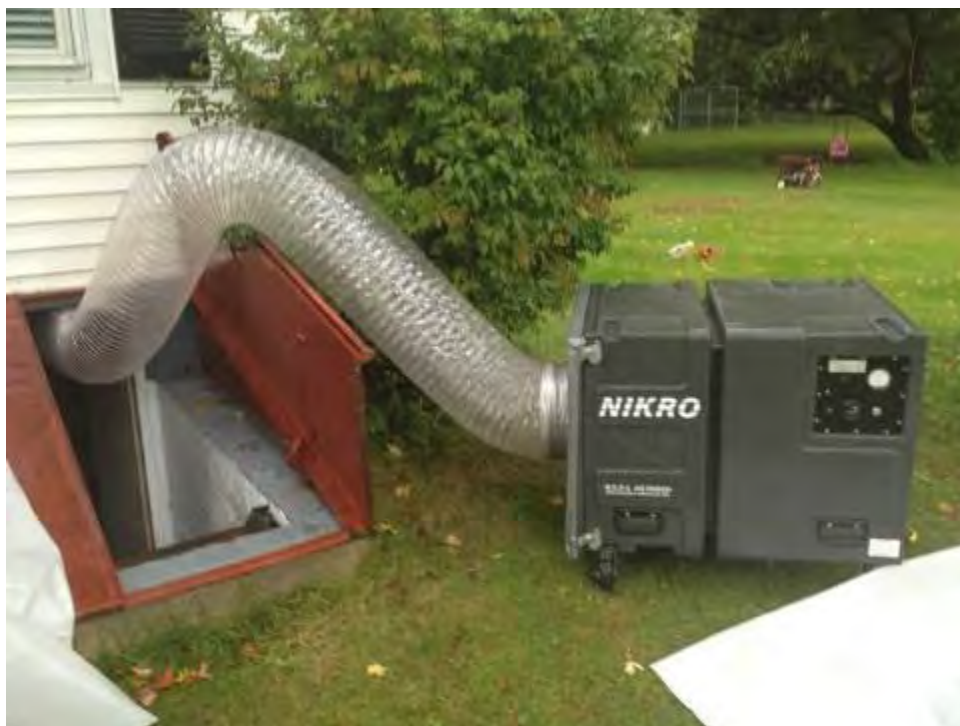
SCENE: View of the negative air system used during decontamination activities at (b) (6)

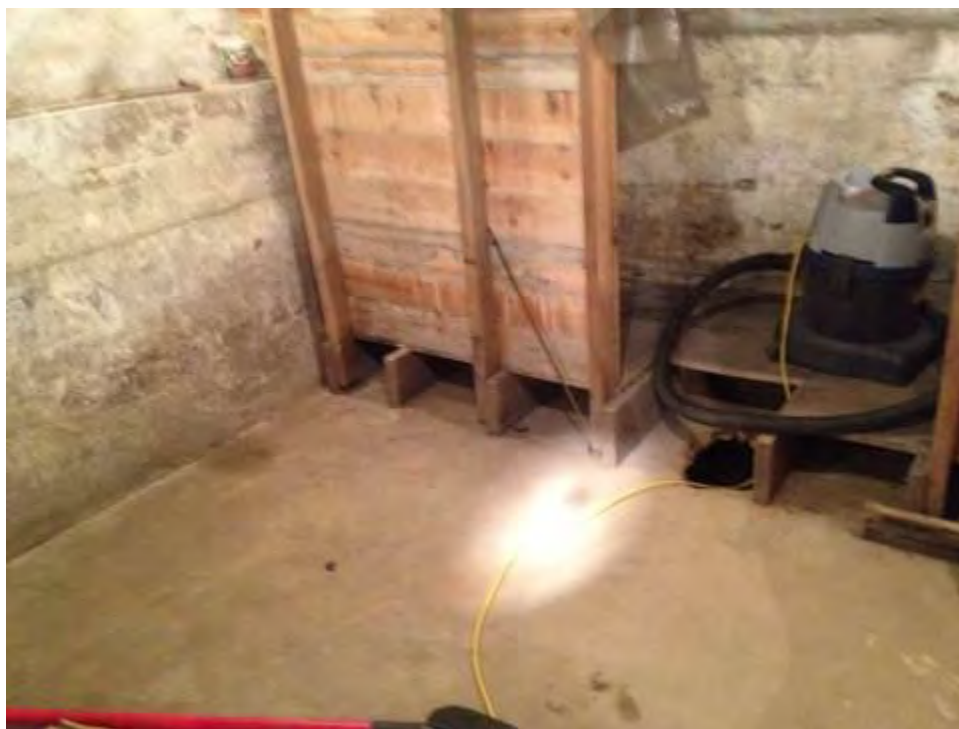
SCENE: View of the northwestern basement area at (b) (6) following decontamination.

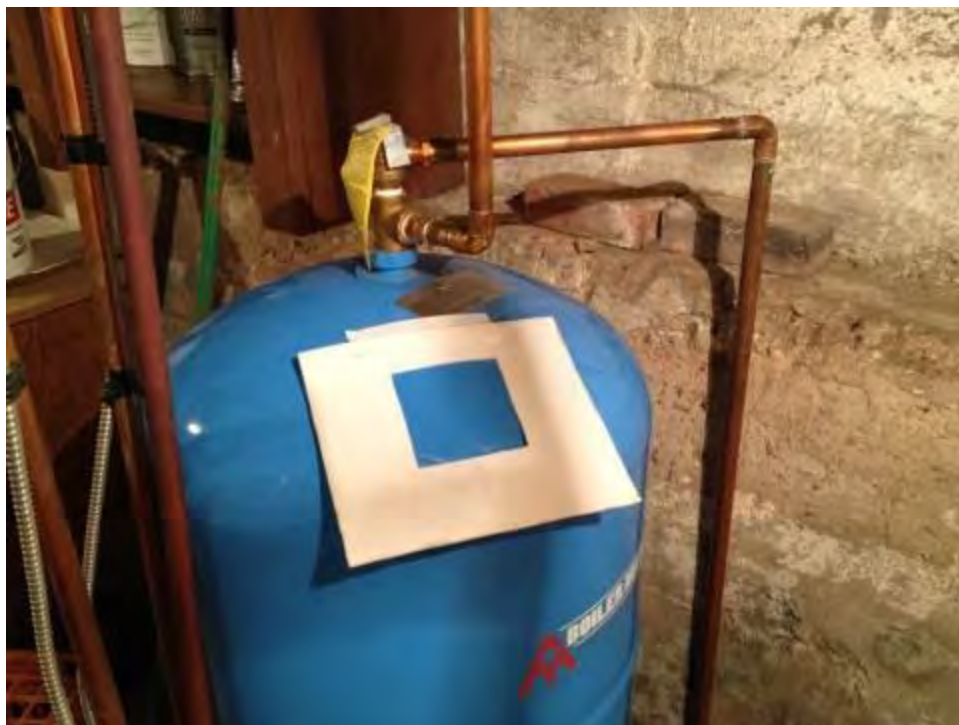
SCENE: View of wipe sample (WS) location WS-01 at (b) (6). The sample was collected following decontamination.

SAMPLE LOCATION SAMPLE NUMBER SAMPLE DATE SAMPLE SURFACE	WS-01 R01-120917DB-0001 9/22/2012 WATER HEATER (b) (6)	WS-02 R01-120917DB-0002 9/22/2012 COAL STOVE (b) (6)	WS-03 R01-120917DB-0003 9/22/2012 COAL STOVE (b) (6)	WS-04 R01-120917DB-0004 9/22/2012 FURNACE (b) (6)
COMPOUND				
Aroclor-1016	ND	ND	ND	ND
Aroclor-1221	ND	ND	ND	ND
Aroclor-1232	ND	ND	ND	ND
Aroclor-1242	ND	ND	ND	ND
Aroclor-1248	ND	ND	ND	ND
Aroclor-1254	ND	ND	ND	ND
Aroclor-1260	ND	ND	ND	ND
Aroclor-1262	ND	ND	ND	ND
Aroclor-1268	ND	ND	ND	ND

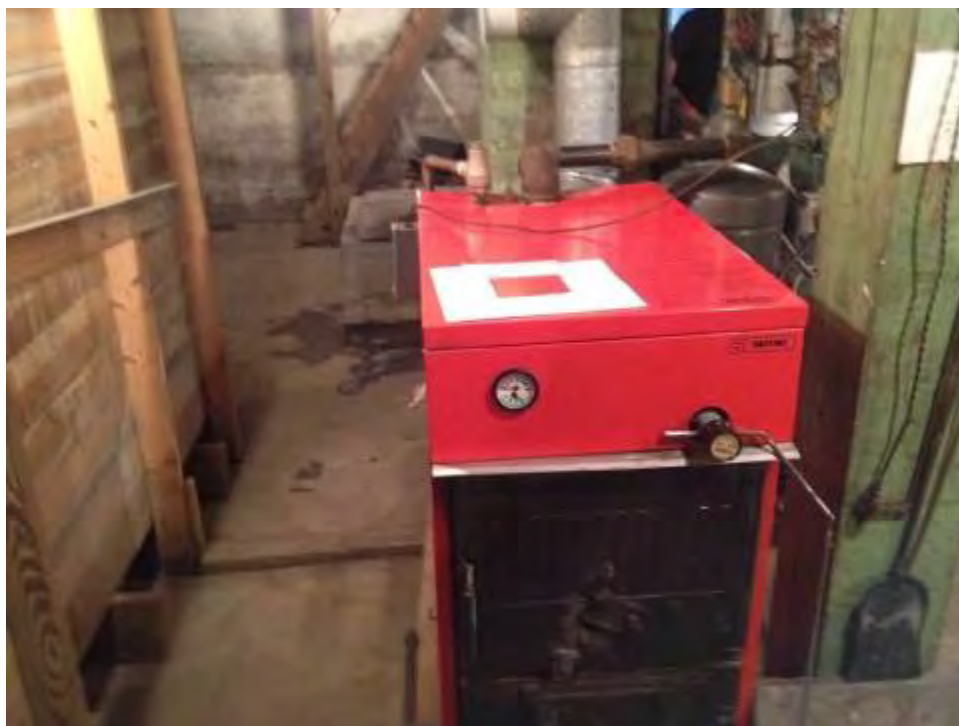
SCENE: View of wipe sample location WS-02 (Duplicate WS-03) at (b) (6). The photograph was taken following decontamination.

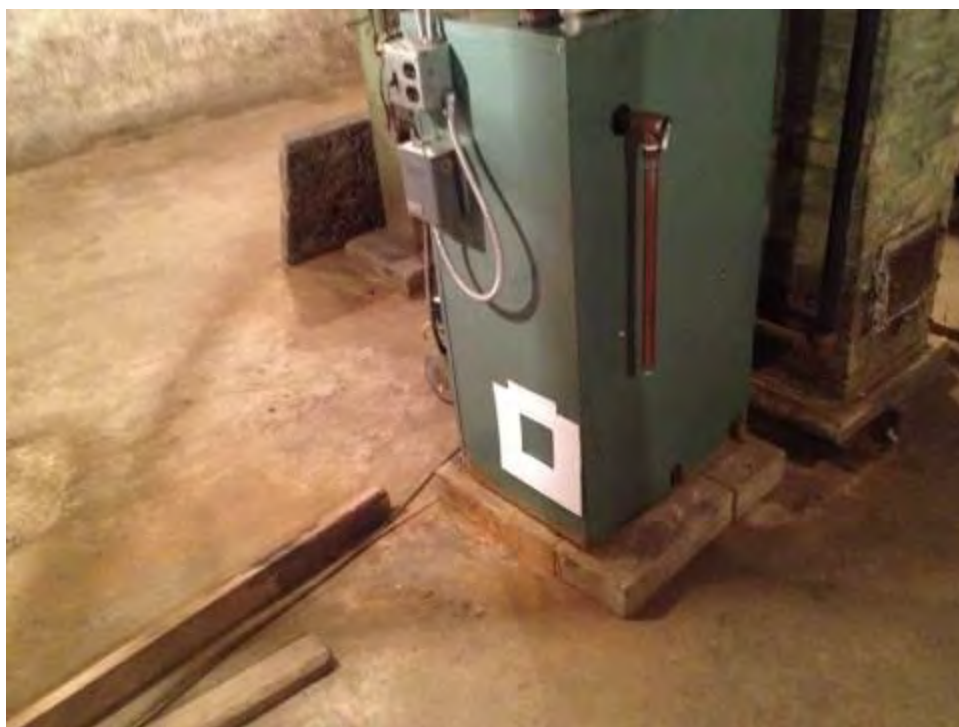
SCENE: View of wipe sample location WS-04 at (b) (6). The photograph was taken following decontamination.

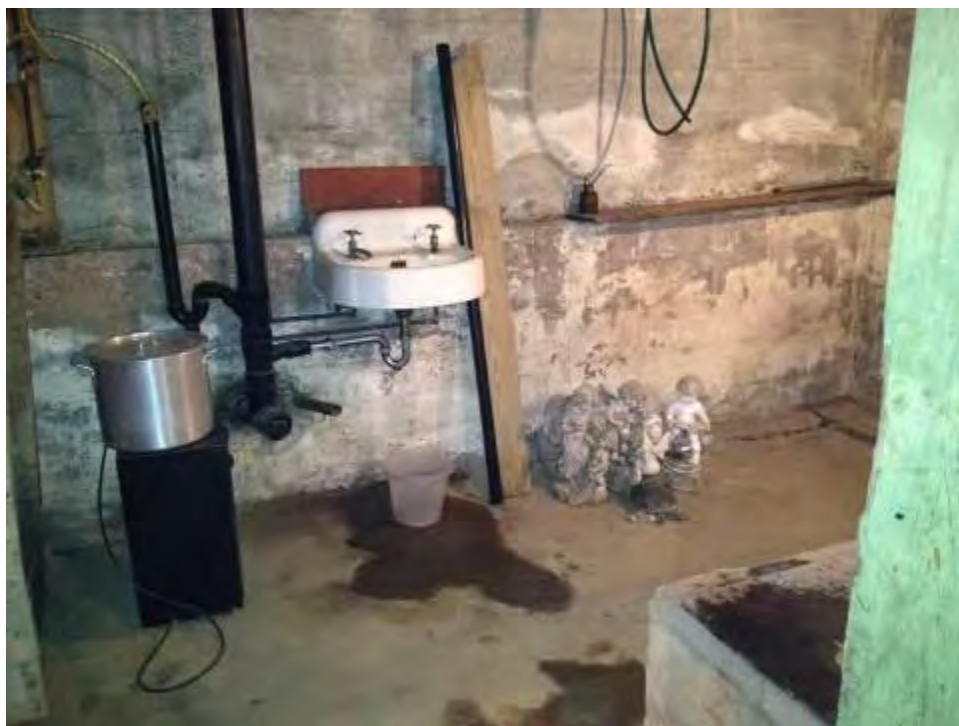
SCENE: View of the northeastern basement area at (b) (6) following decontamination.

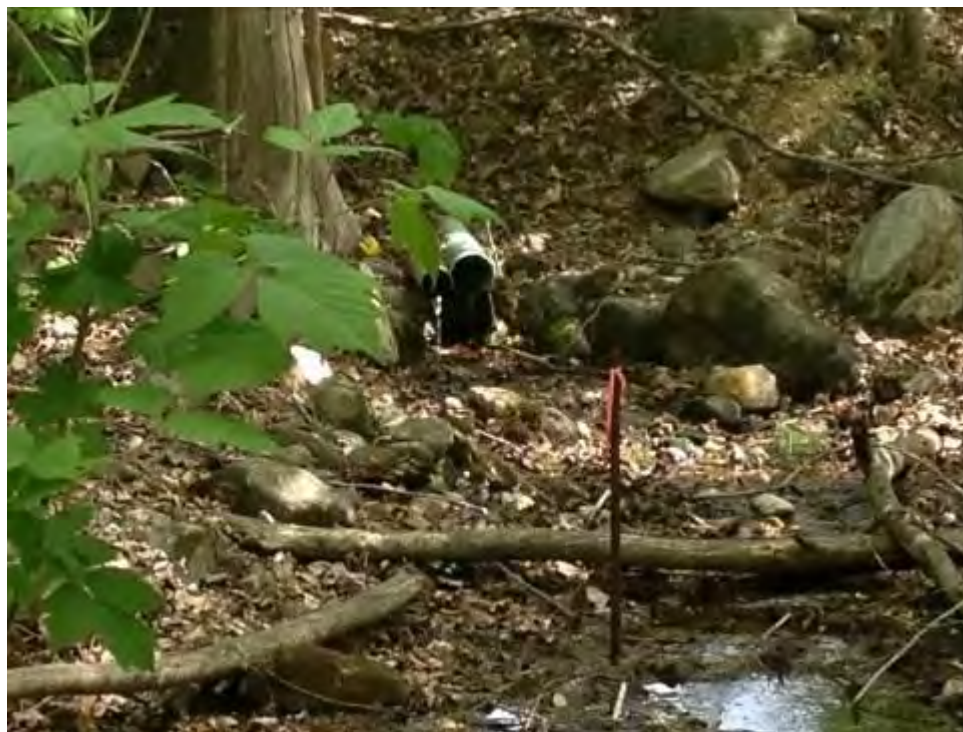
SCENE: View of the suspected effluent piping from the former sump pump system of (b) (6). Photograph taken facing south.

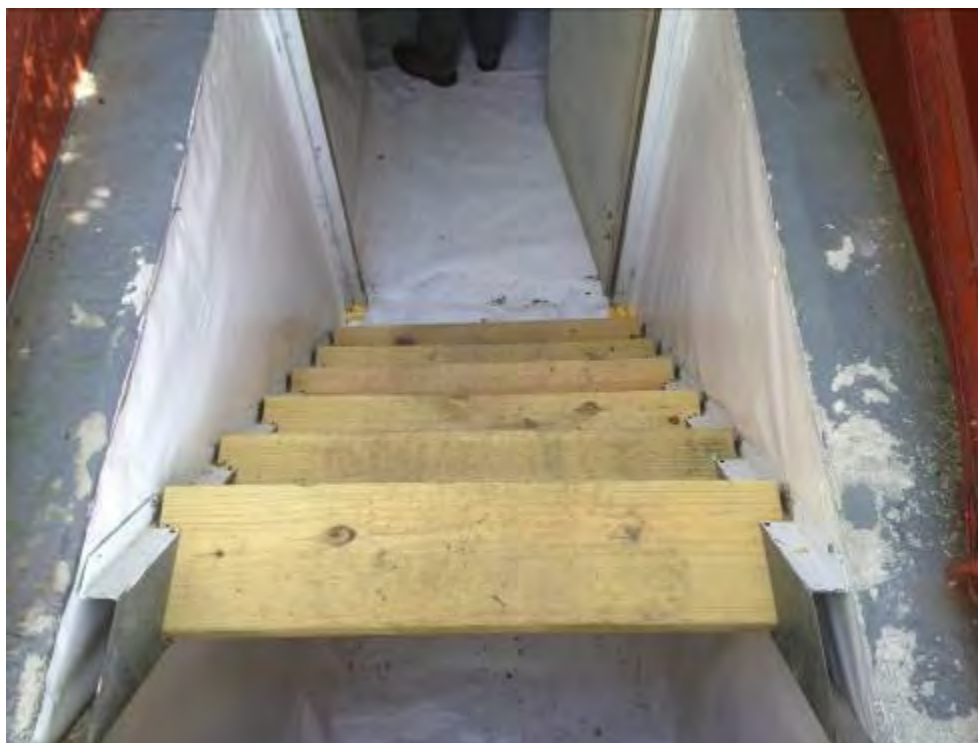
SCENE: View of basement stairs after installation of a polyethylene (poly) liner at (b) (6). Photograph taken facing north.

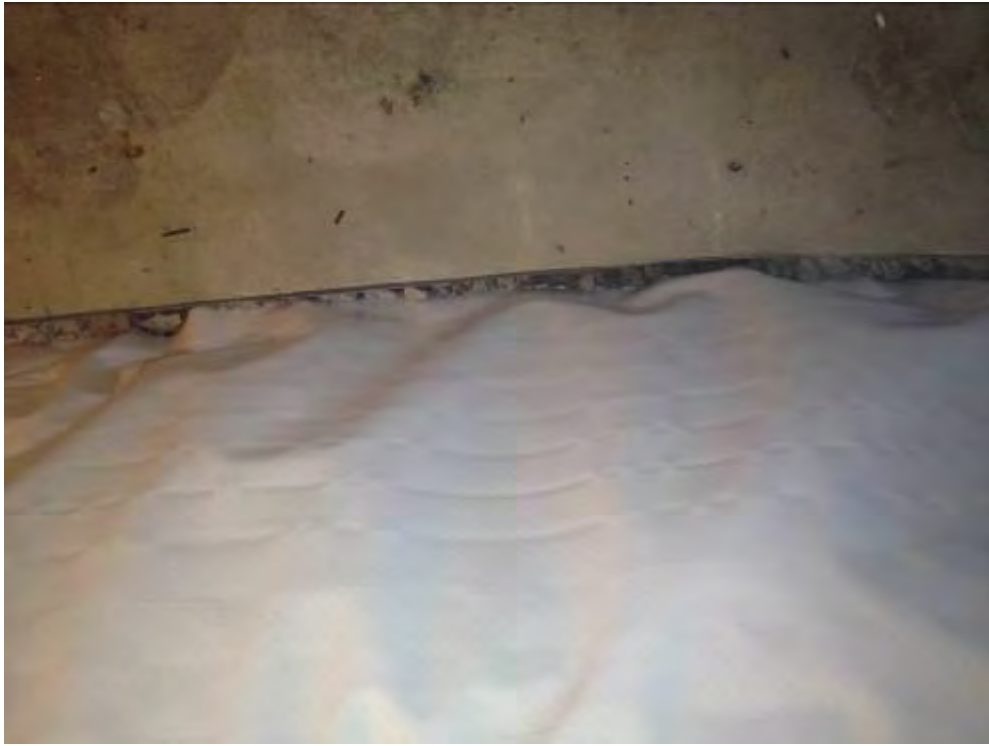
SCENE: View of the poly liner on the wall and the French drain system in the (b) (6) basement.

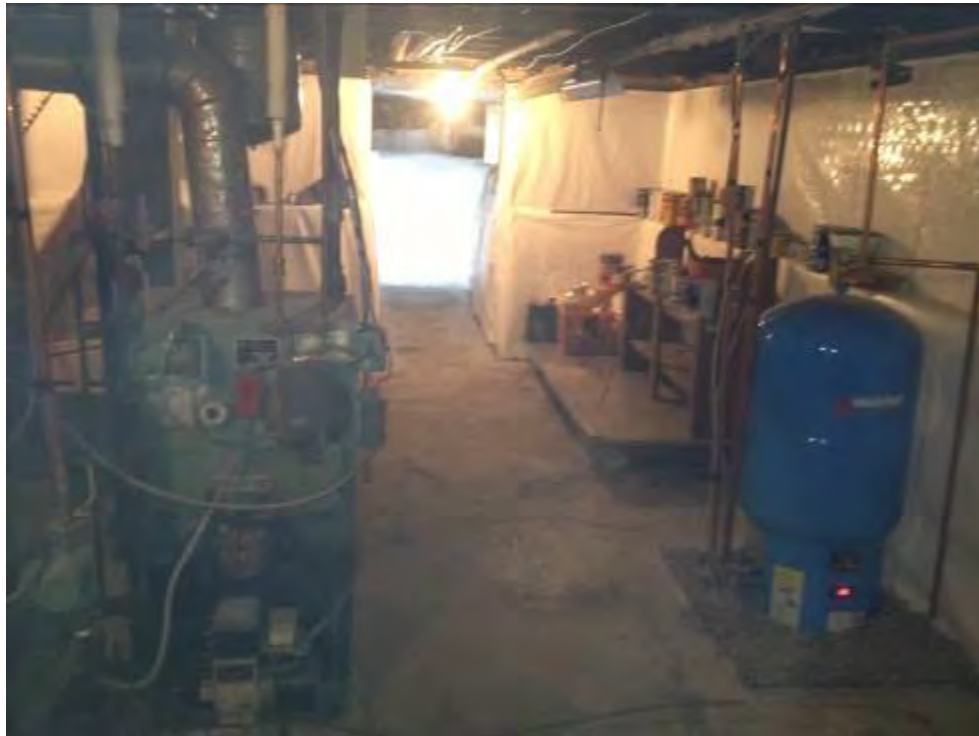
SCENE: View of stored materials and the furnace area of the (b) (6) basement after the installation of poly liner and a French drain system. Photograph taken facing east.

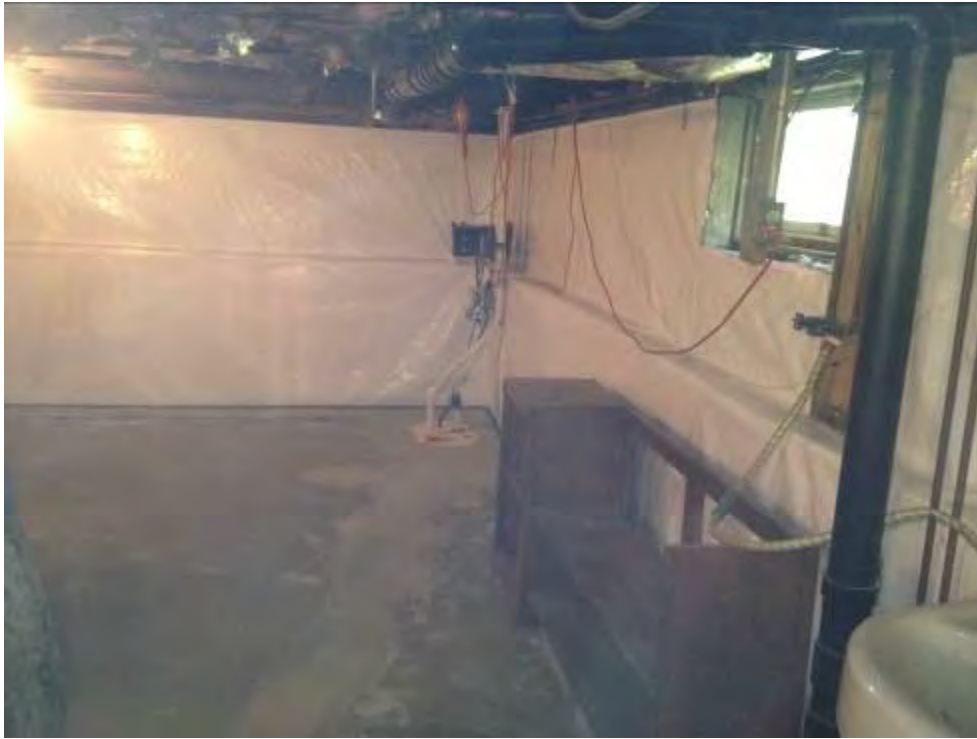
SCENE: View of the sump pump system and poly sheeting installed in the northwest corner of the basement of (b) (6)
[REDACTED] Photograph taken facing west.

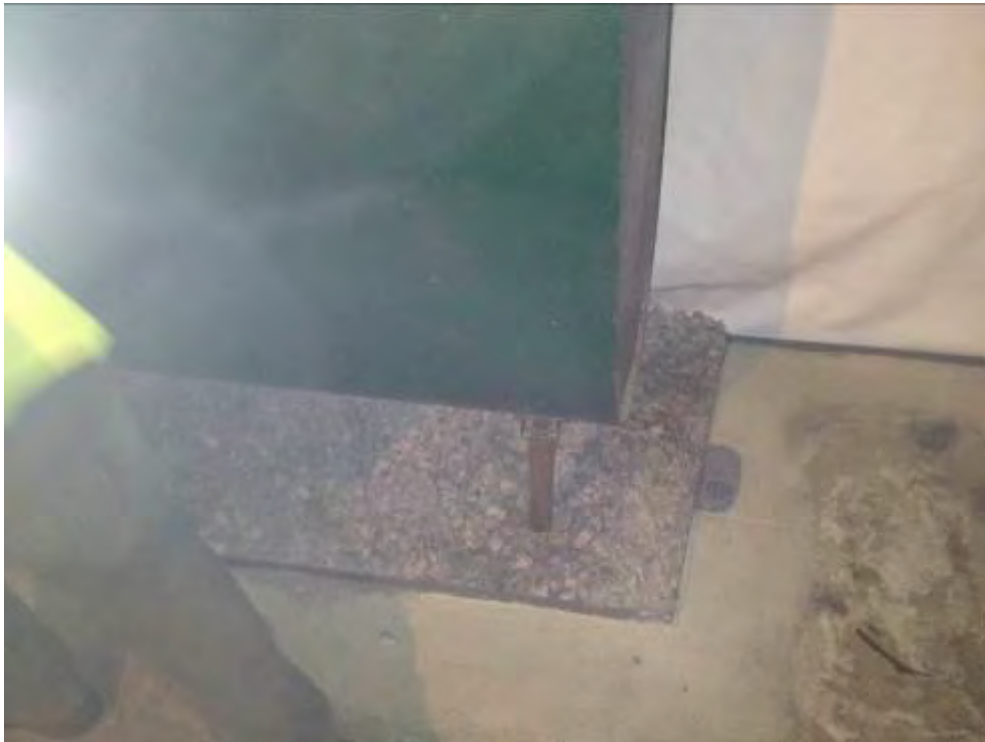
SCENE: View of the aboveground storage tank (AST) that was staged on a crushed gravel platform after the installation of a poly liner and French Drain system in the basement of (b) (6)

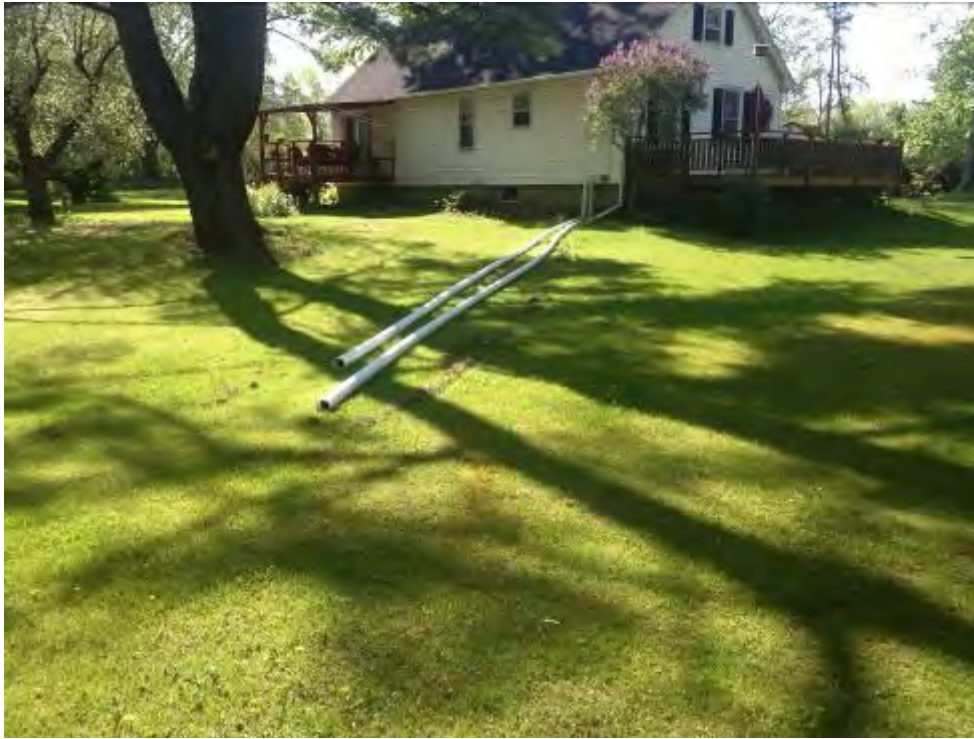
SCENE: View of effluent piping from the sump pump system from the (b) (6) basement. Photograph taken facing southeast.
